# **Polymer Composite Wrapping and Cathodic Protection System for Reinforced Concrete Piles in Marine Applications**

Final Report on Project F08-AR07

Under Project F08-AR07, "Polymer Composite Wrapping and Ceramic Anode Cathodic Protection System for Pilings at Kawaihae Harbor, HI

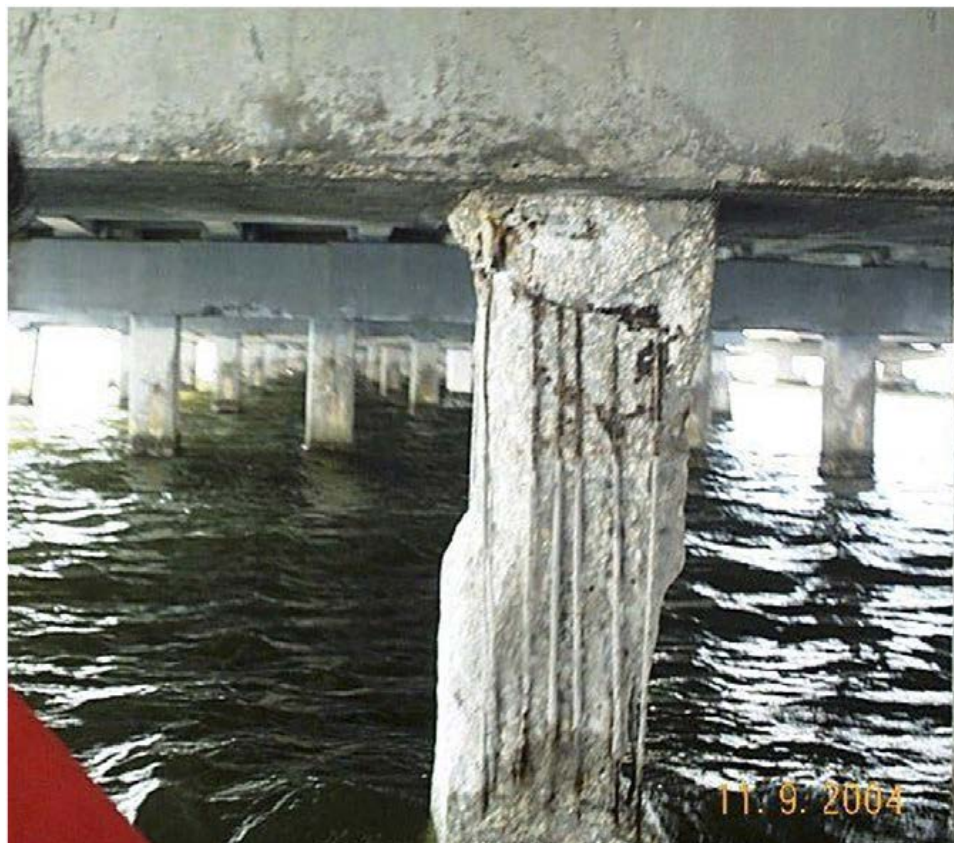
Figure 1. Cracking and spalling of concrete pile due to steel corrosion.

For marine piles, simple patching of the deteriorated concrete is usually only a temporary solution because it does not stop corrosion of the reinforcement caused by the continued presence of chlorides, moisture, and oxygen from the seawater. In fact, corrosion rates may be accelerated in the vicinity of new patches.

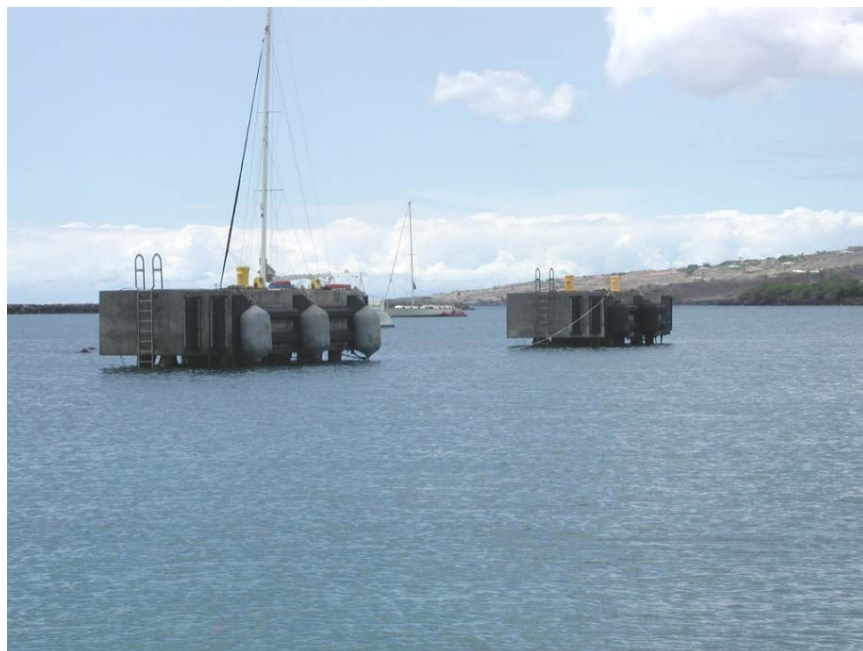
Figure 2. Dolphin 2 and 3 at Kawaihae Harbor.

Dolphins 2 and 3 were built in 2000. They are reinforced concrete platform/pile cap structures measuring approximately 34 ft long by 14 ft wide by 6.5 ft deep. The bottom of the pile cap elevation for each is approximately 4 ft above mean sea level (+4.0 ft MSL). The structures (Figure 2) are supported by gangs of prestressed concrete piles driven directly into the bottom of the harbor sea floor. Dolphin 2 has 21 piles and Dolphin 3 has 19 piles.

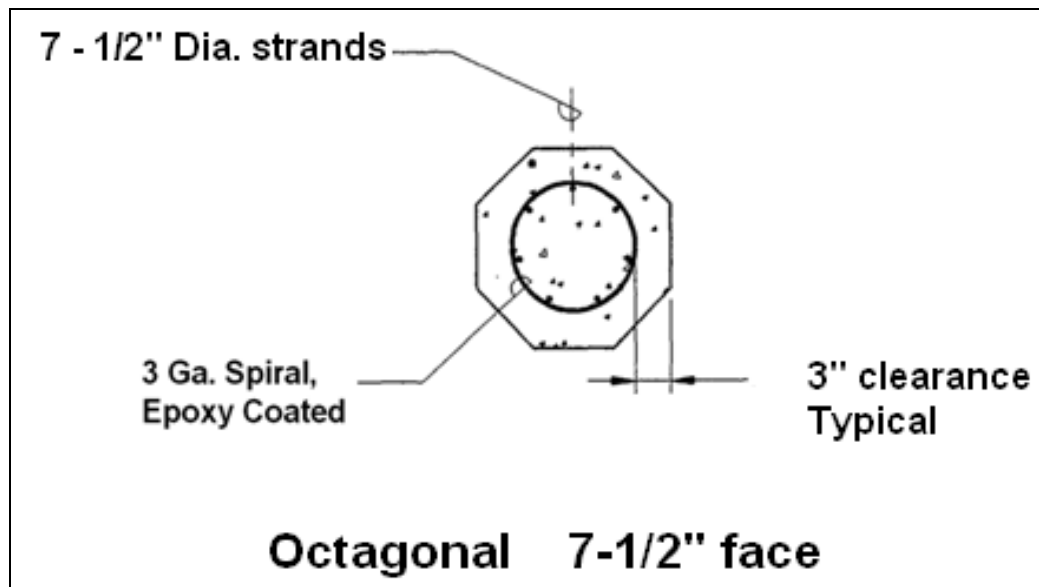
Figure 3. Cross-section of typical support pile.

The piles are about 70 ft long and have octagonal cross-sections with 7.5 in. faces (Figure 3). They are in relatively good condition, with indications of only very minor damage within the splash zone region. The chloride ion contamination profile extracted from one of the piles indicates chloride contamination has penetrated beyond a depth of 2 in. into the concrete, but has not yet reached the prestressing tendons.

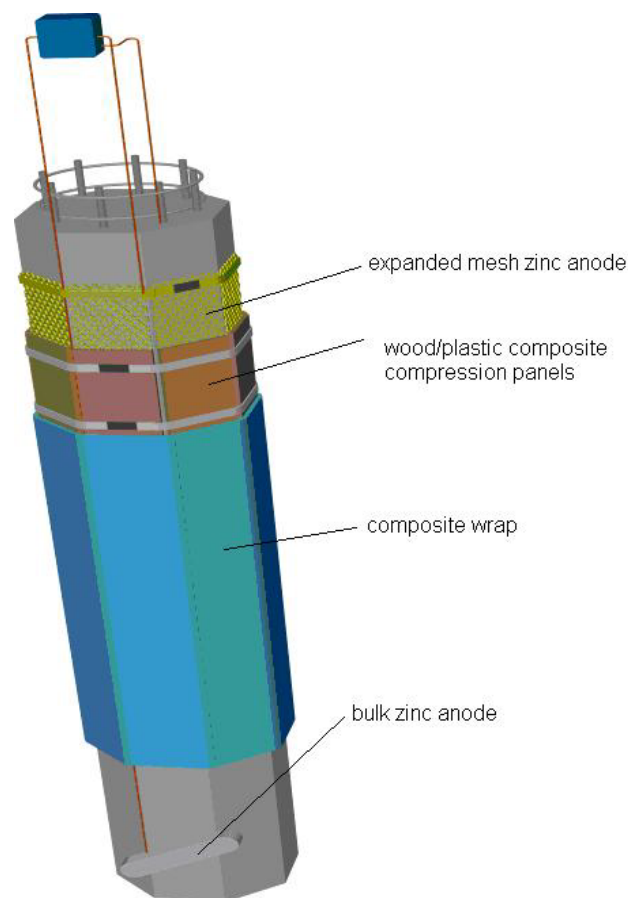
Figure 4. ICPW system components.

The contractor's proposed design (Figure 4) integrates three technologies: FRP composite wrap, galvanic CP, and corrosion monitoring.

The composite wrap system encapsulates the pile in the splash zone and provides protection against abrasion and mechanical damage to the pile surface and the CP anode assembly underneath it. The wrap material is a woven glass fiber pre-impregnated with moisture-activated resins that cure underwater after being put in place.

The CP anode assembly that protects the wrapped section of pile is composed of expanded mesh strips and compression panels. The mesh strips, made of high-purity zinc, are placed against each face of the octagonal pile. They function as sacrificial anodes to protect the reinforcement steel in the wrapped portion of the pile. The strips are held against the pile surfaces by wood composite compression panels that are banded in place. A bulk zinc anode supplements the integrated CP system and provides protection for the reinforcement steel in the unwrapped portion of the pile.

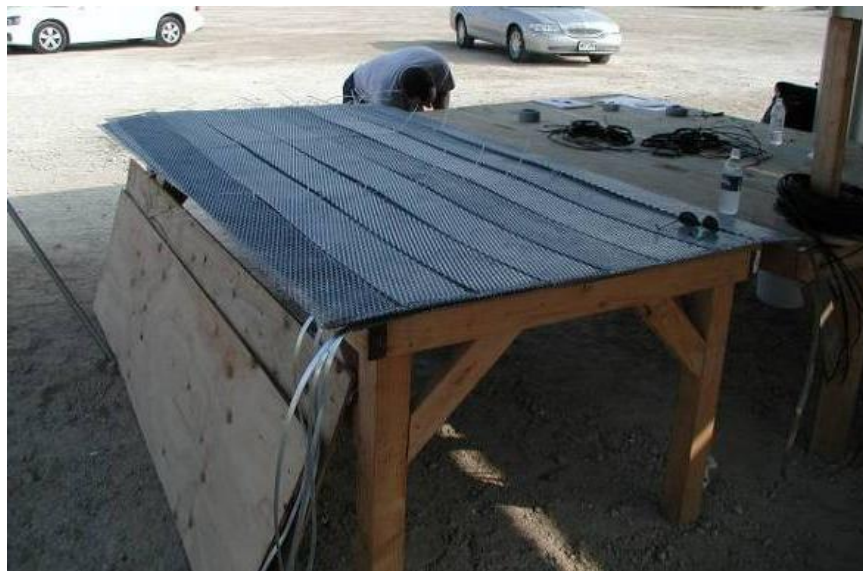
Figure 6. Assembled apron of eight mesh anode strips.

While the dive crew prepared the piles, the contractor's CP installation crew performed other preparation tasks. They assembled aprons consisting of eight of the individual zinc mesh strips spaced to properly align with a pile face when wrapped around the octagonal pile (Figure 6). The sheets were attached by soldering a 0.75 in. strip of anode-grade zinc around the top of all sheets, with a "tag" end remaining for attachment to a 14 AWG HMWPE anode cable. The compression panels were cut to the correct length and the longitudinal grooves were cut on one face. The CP installation crew also field-calibrated the reference electrodes to ensure that the cells functioned according to the design specifications.

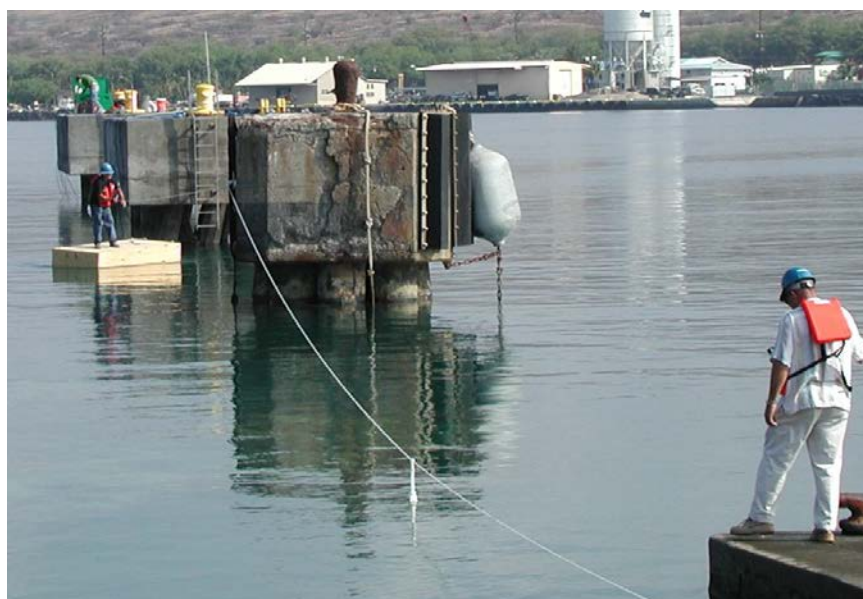
Figure 7. Floating raft used to transport materials and crew.

After the piles were cleaned and the crew completed the shore-side preparation activities, installation work at the two dolphins began. The CP installation crew constructed temporary rafts to transport themselves as well as components, materials, and tools from the shore to the piers. These floating rafts (Figure 7) were bottomless boxes constructed of plywood encasing one or more large chunks of polystyrene. Additional rafts were constructed and braced between piles to provide working platforms beneath the dolphin structures.

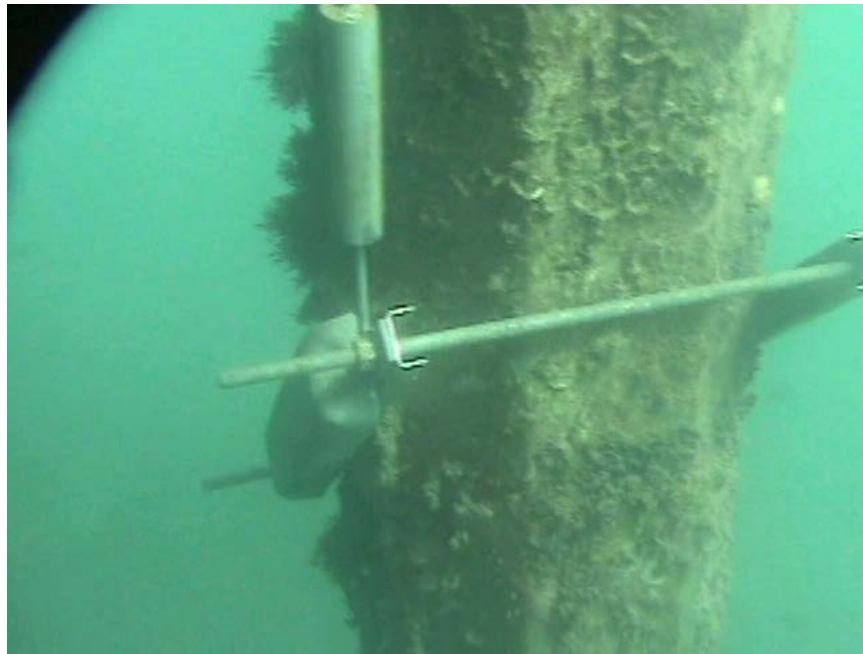
Figure 8. Bulk anode installed at -8.0 MSL elevation.

On each of the protected piles, the dive crew installed a bulk zinc anode assembly at the -8.0 ft elevation. The anode was clamped to the pile using a 2 in. galvanized steel channel (Figure 8) with the flanged side placed against the pile surface and two hot-dip galvanized carriage bolts of 5/8 in. diameter extending to the anode. The anode connector cable was attached to the steel strap core, which was connected to the assembly. The cable, which would later be connected at the other end to the RMU, was temporarily secured to the pile using nylon ties.

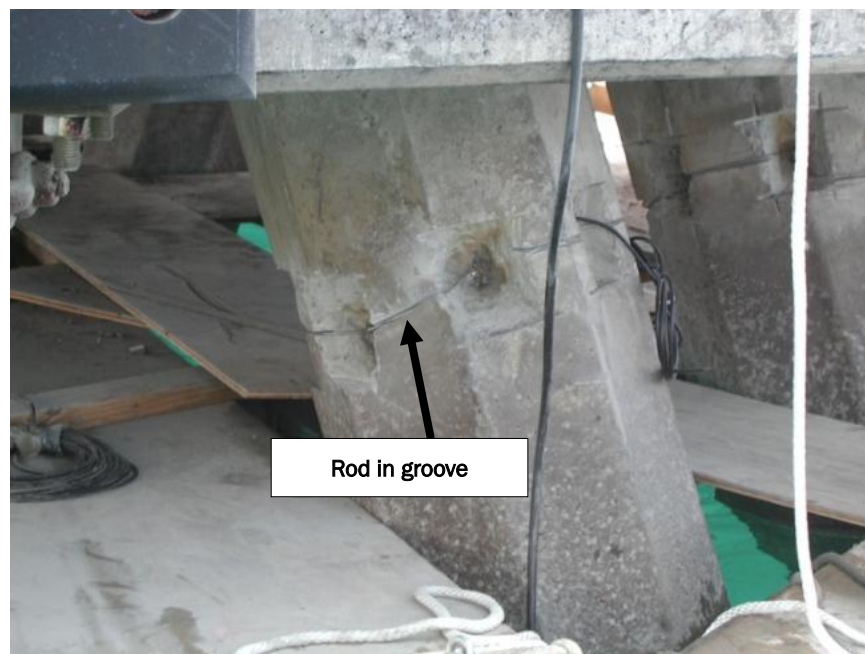
Figure 9. Plugs removed and steel rod placed in grooves.

For each pile, the steel rod was welded to each of the exposed tendons and spiral tie. Next, two negative connections to steel were made. Each connection consisted of a 14 AWG cable connected to a 3/16 in. diameter steel

tube soldered to the bared end of the cable. The tube was flattened and then welded to the spiral tie or tendon. The joint between the wire insulation and steel tab was coated with a waterproof rubberized liquid electrical coating. The welds were cleaned, and continuity verification measurements were taken between all reinforcing and negative connection wires.

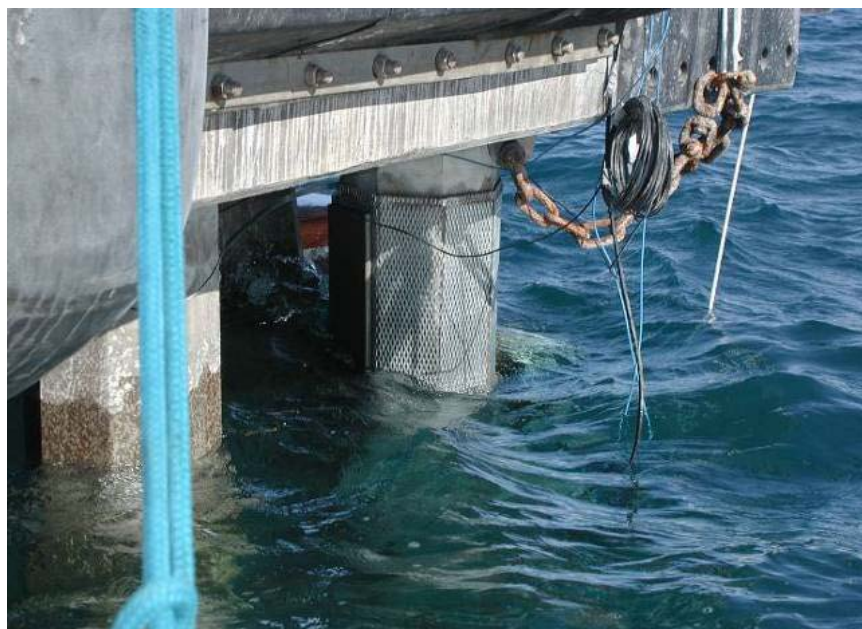
Figure 10. Anode assembly positioned against pile.

After the bulk anodes and reference electrodes were in place, the dive crew was able to begin installing the zinc mesh anode aprons and compression panels (Figure 10). This process required the use of a temporary work platform affixed to the pile at the -5.5 ft elevation. The platform, consisting of fabricated friction collars with a plywood deck, enabled the divers to place the zinc mesh and compression panels at the required elevation.

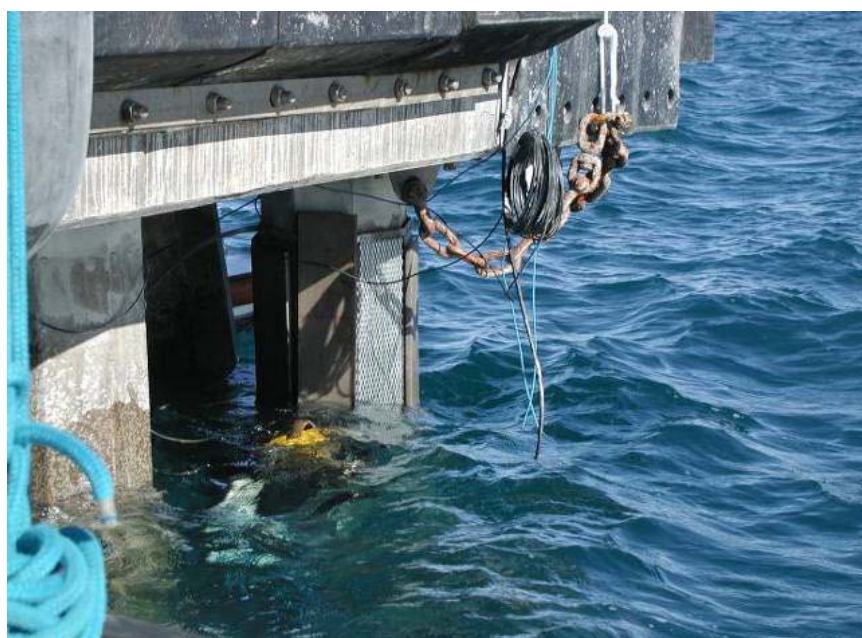
Figure 11. Diver placing compression panel over anode assembly.

Each apron assembly, once set into position, was held in place using plastic tie wraps. The divers placed a compression panel against each of the eight pile faces (Figure 11) and used elastic cords to temporarily hold them in place. The panels were permanently secured with stainless steel banding affixed at 1 ft increments from top to bottom. Next, the dive crew removed the work platform and routed the cable leading to the bulk anode through a piece of conduit placed between two adjacent compression panels.

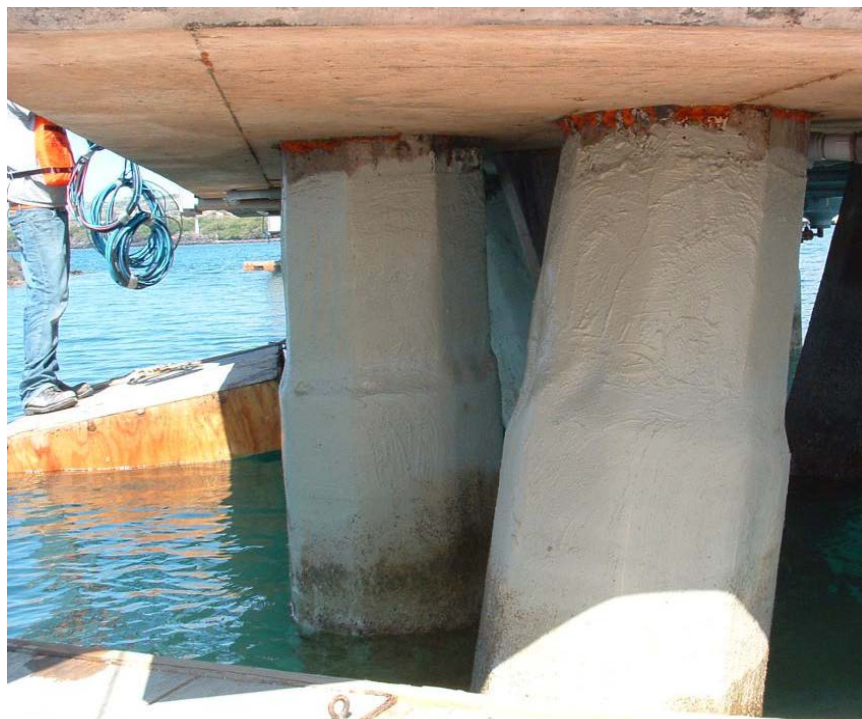
Figure 12. Finished composite wrap assembly.

For each pile, the divers removed the wrap material from the sealed bag and applied it by winding tangentially around the pile to cover the assembly. The wrap was applied in a manner to provide three plies of coverage. For portions of the application that were above the waterline, water was sprayed on each layer of material as it was being installed. As prescribed by the system manufacturer, a stricture band made of plastic sheeting was then placed around the composite wrap to remain during initial curing and help ensure compression against the pile. The sheeting was perforated with a special tool to prevent carbon dioxide build-up beneath it. Once the composite hard to the touch through the plastic, the sheeting was removed and the wrap was allowed to cure for three more days. The wrapped area was then coated using the same primer that was applied beneath the wrap. The finished composite wrap assembly is shown in Figure 12.

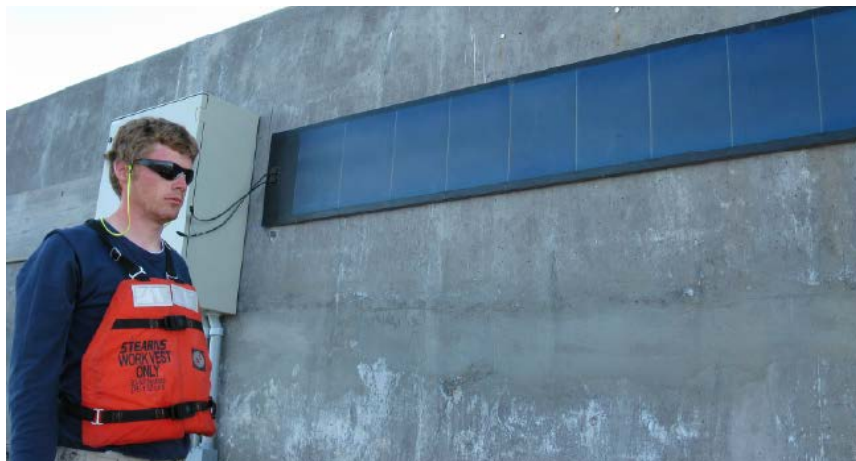
Figure 13. RMU and PV panel mounted on west face of dolphin pier.

The RMUs and PV power panels were installed on the west face of each dolphin (Figure 13), opposite the landing area. The west face was least susceptible to damage and provided adequate sunlight for the PV power. All conduits were routed to the RMUs in a manner to reduce the number of openings and wire pulls. The conduits and junction boxes were secured to concrete surface on the undersides of the dolphins (Figure 14). Nylon fasteners were used to attach the junction boxes. The same fasteners in combination with PVC straps, spaced every 12 in., were used to attach the conduit. Splices were avoided for all wiring except for the zinc strap/wiring transition for the zinc mesh connection.

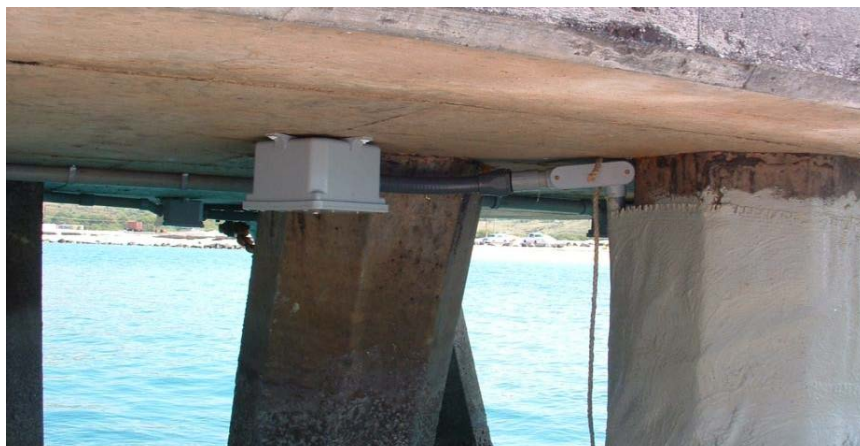
Figure 14. Junction box and conduit attached to underside of pier.

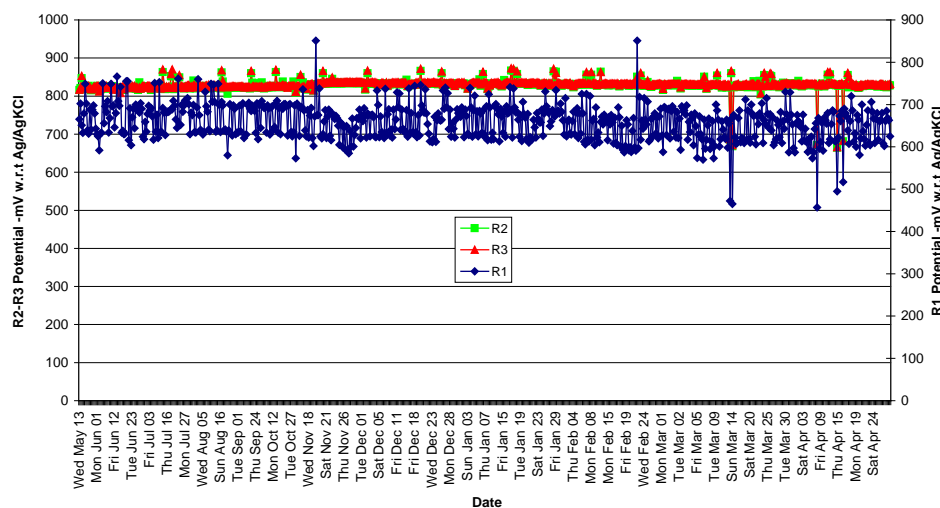
Figure 15. Instant-off potentials for first year, Dolphin 2, Pile 1 (full system).

terion are being met. For all four monitored piles, the metric is being met for all but two reference electrodes. For Pile 1, R1 readings are in the range of -600 to -700 mV. For Pile 11 (Figure 19), R2 has negative potential readings below  $>-500\text{mV}$ , which would be unlikely in this type of application, so the reference electrode is considered to be faulty. For Pile 21 (Figure 21), R2 and R3 become erratic in their behavior after 10 months, but neither reference electrode has shown to be faulty.

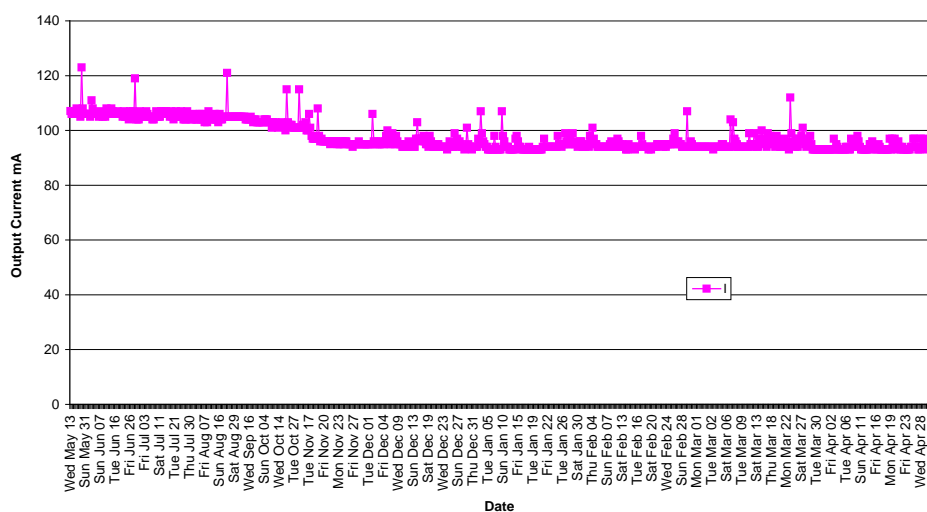
Figure 16. Output current for first year, Dolphin 2, Pile 1 (full system)

The anode output currents measured for each of the monitored ICPW piles on Dolphin 2 can be seen in Figure 16, Figure 18, Figure 20, and Figure 22. Each of the output currents for Piles 1 and 3 shows a reduction in current demand from the initial energizing level, which begins to occur at about the fourth month of service. The reductions are most likely to be due to the existing corrosion cells and chloride levels within the concrete. As the CP system is changing the environment around the corrosion cells, less current will be required as the passivating film increases current resistance to the steel. The more corrosion cells there are, the longer it will take to stabilize the system output current.

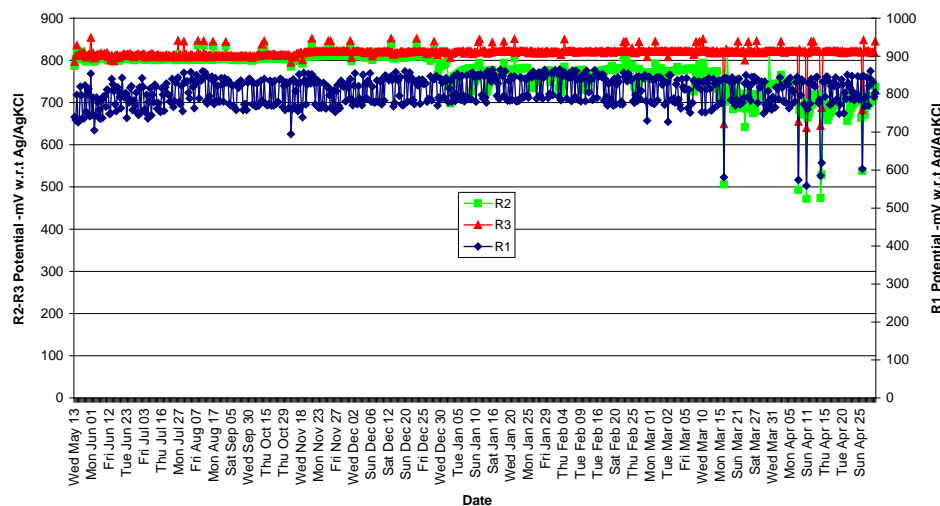
Figure 17. Instant-off potentials for first year, Dolphin 2, Pile 3 (full system).

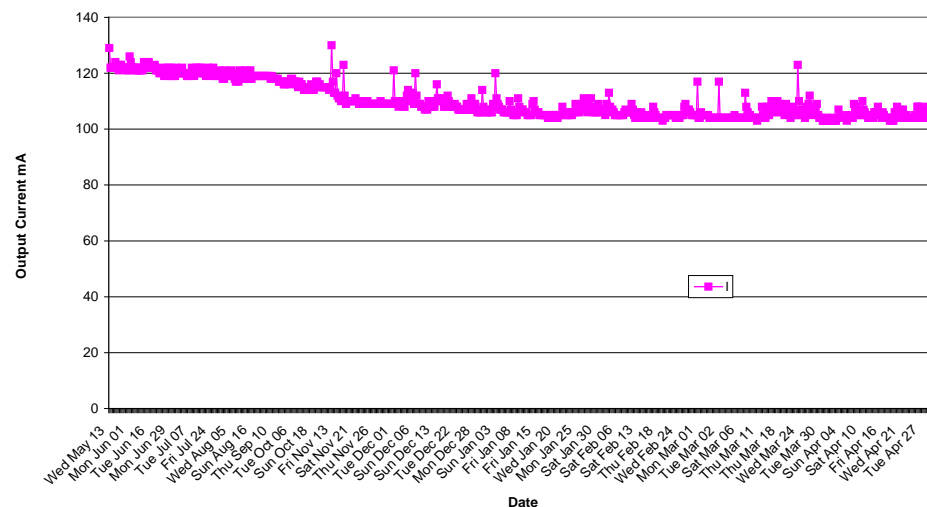
Figure 18. Output current for first year, Dolphin 2, Pile 3 (full system).

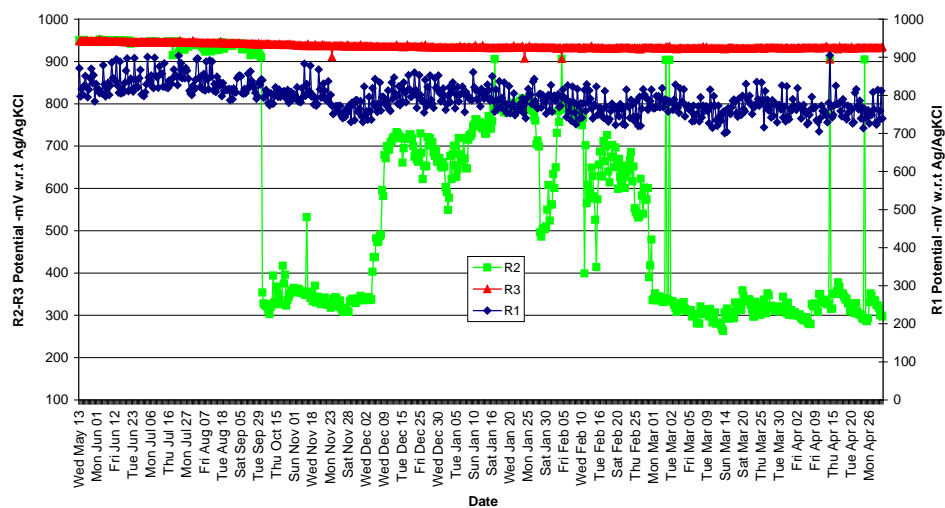
Figure 19. Instant-off potentials for first year, Dolphin 2, Pile 11 (full system).

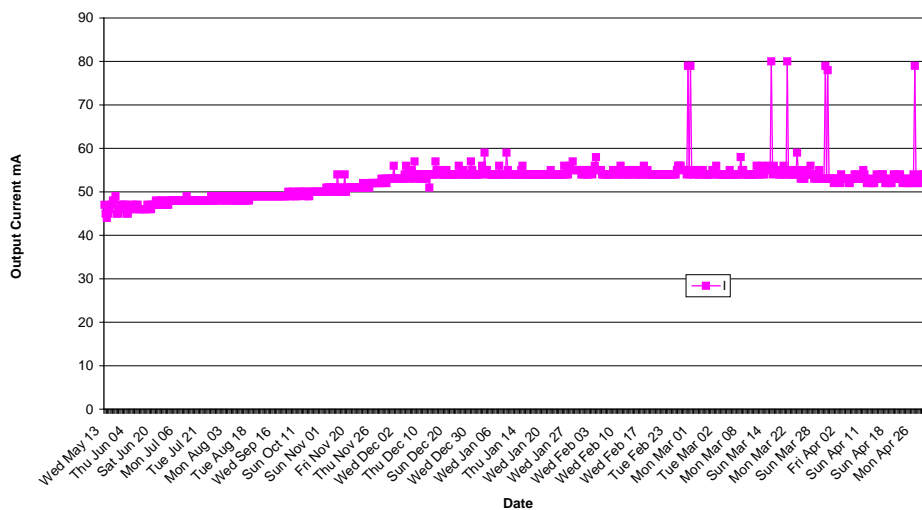
Figure 20. Output current for first year, Dolphin 2, Pile 11 (full system).

The output current for Pile 11 shows an increase in current demand from the initial energizing level. As corrosion cells are changing within the structure, if chloride or moisture levels change then there will be a tendency for the system to demand more current.

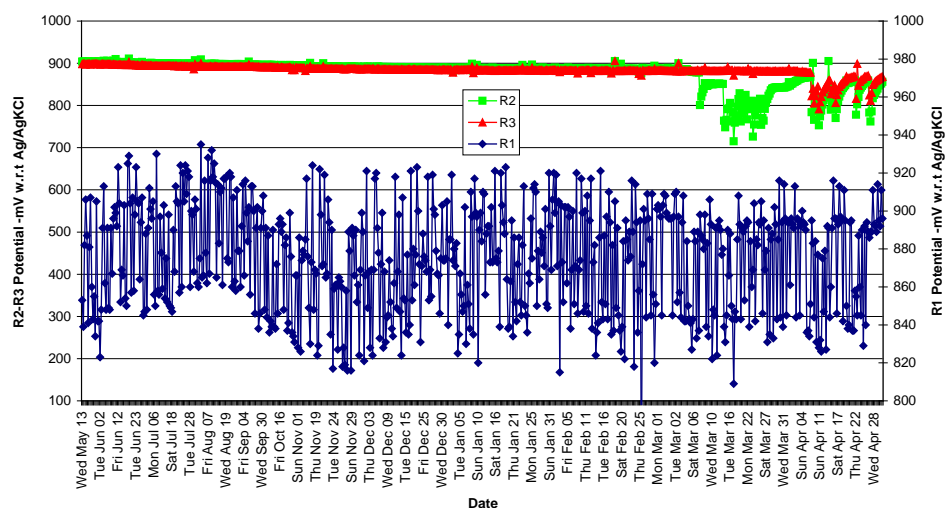
Figure 21. Instant-off potentials for first year, Dolphin 2, Pile 21 (full system).

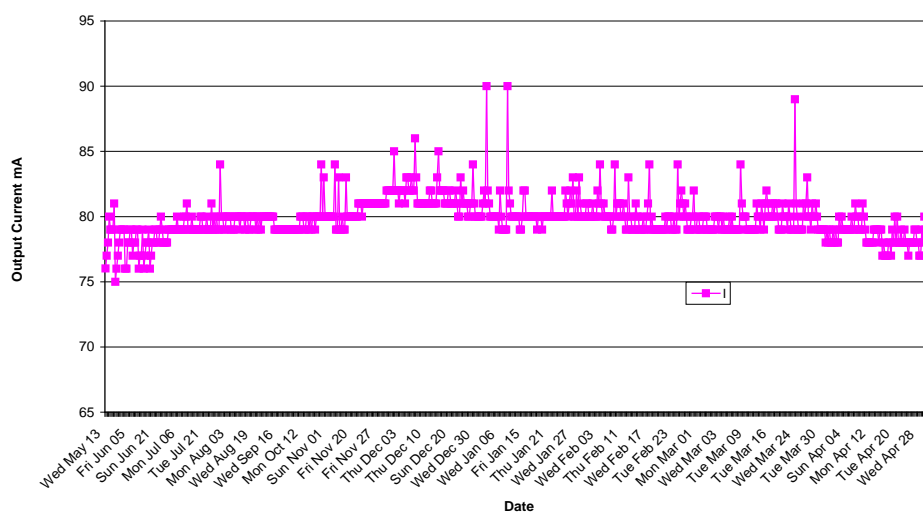
Figure 22. Output current for first year, Dolphin 2, Pile 21 (full system).

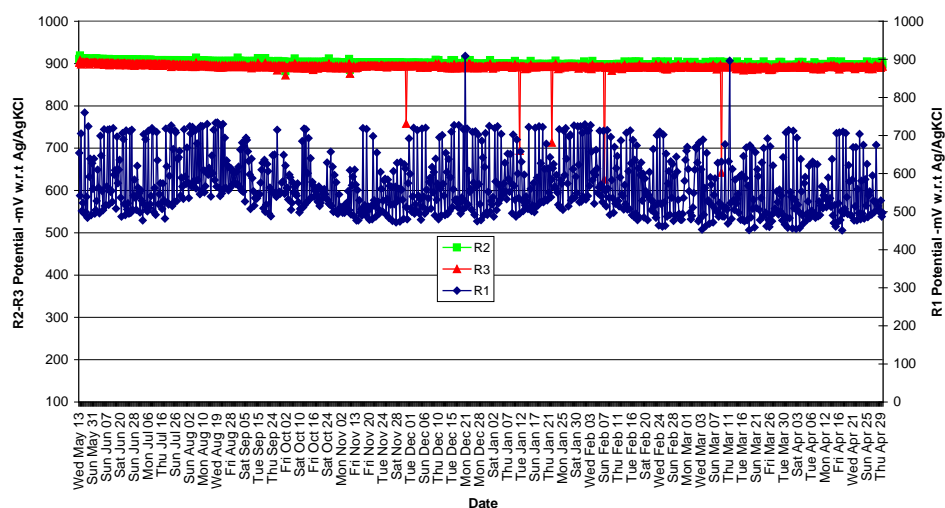
Figure 23. Instant-off potentials for first year, Dolphin 2, Pile 17 (wrap and bulk CP).

Pile 17 has the composite wrap and a bulk anode protecting the unwrapped portion of the pile. There was no wire mesh anode installed with the wrapped section, so the pile does not have a disconnectable anode. This design prevents the monitoring system from logging the anode output and carrying out depolarization tests. The instant-off potentials exhibited in Figure 23 indicate that CP is being provided to the unwrapped portion of the submerged pile section (R2 and R3). R1 readings show that the wrapped portion has been protected randomly, which is possibly due to changing moisture levels in the concrete related to tide and wave action. Therefore, it cannot be assumed that a submerged anode alone can ensure the long-term durability of a pile.

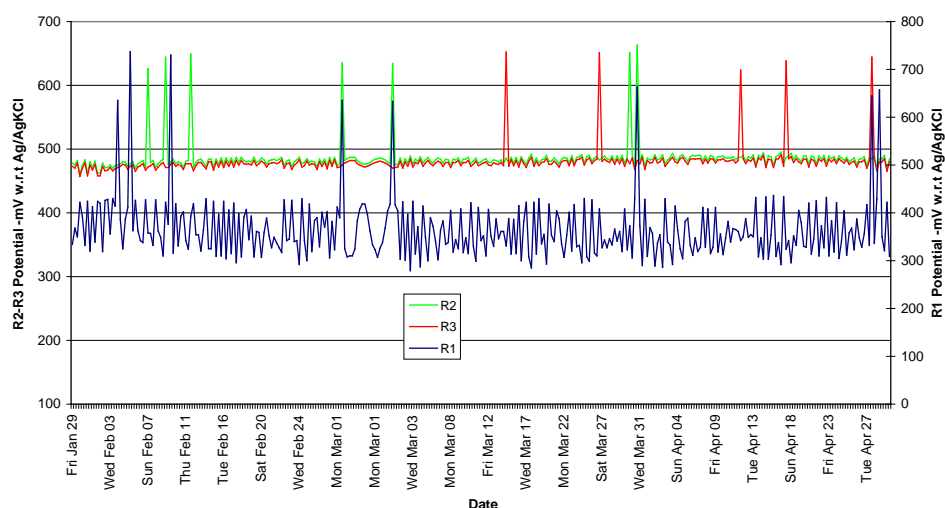
Figure 24. Instant-off potentials for first year, Dolphin 2, Pile 13 (wrap and no CP).

Pile 13 is wrapped but does not include any CP. Pile 15 had no wrap and no CP. During a site visit at the end of 2009 to establish remote access to the MCU and perform a firmware upgrade of the system, it was learned that the data for these piles were found to be in error. At that time, changes in the data-collection system were made to provide correct logging. The instant-off potentials from that point forward for both piles are shown in Figure 24 and Figure 25, respectively. It can be seen that no CP is being provided at any of the three reference electrodes for either pile.

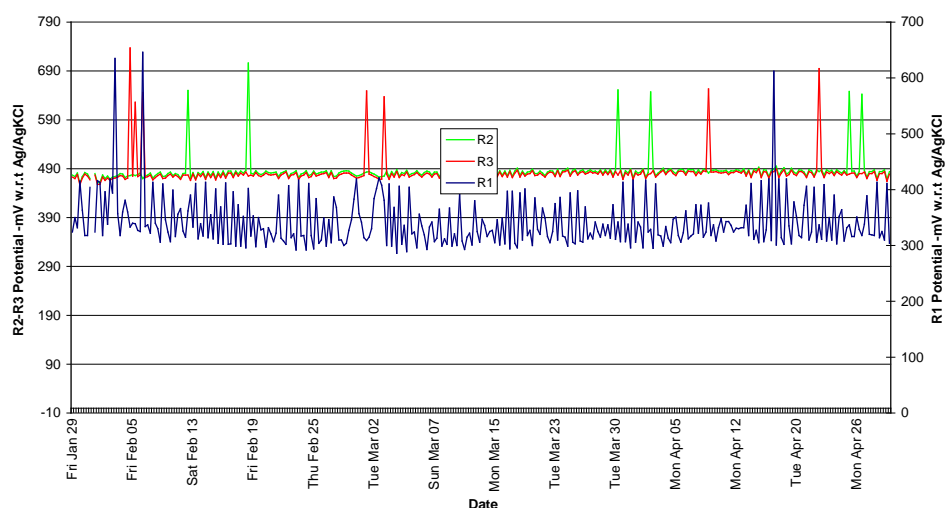
Figure 25. Instant-off potentials over first year, Dolphin 2, Pile 15 (no wrap or CP).

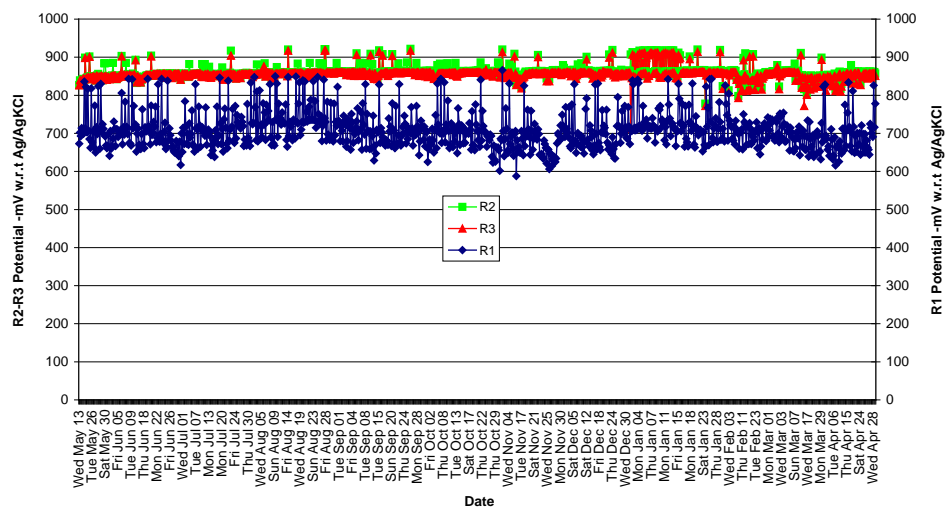
Figure 26. Instant-off potentials for first year, Dolphin 3, Pile 2 (full system).

The data also show that the CP criterion is being met intermittently within the wrapped section of the pile (R1) for three of the four piles. For Pile 12, the instant-off potentials are predominantly more negative than -720 mV, indicating corrosion protection throughout the year. The readings for the reference electrodes R2 and R3 indicate corrosion protection for all four piles, with the reading for Pile 12 exhibiting an increase in fluctuation during the last 4 months.

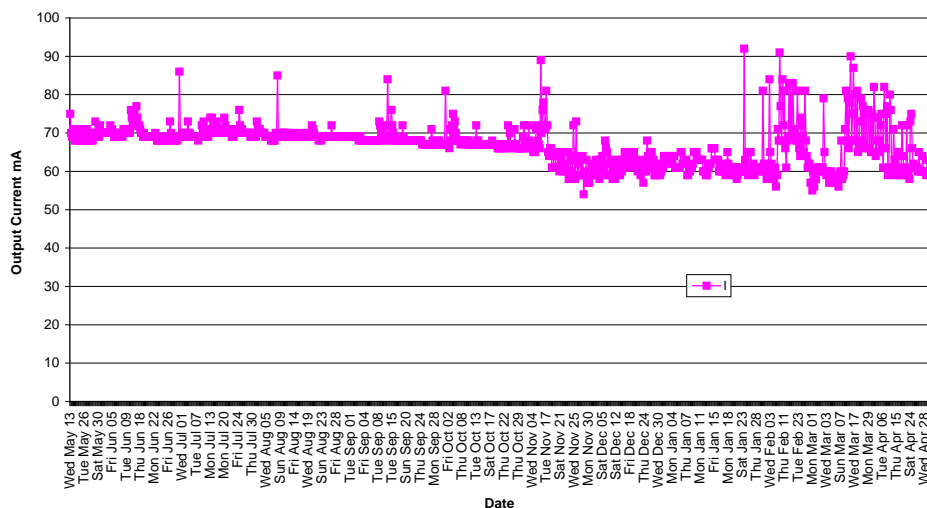
Figure 27. Output current for first year, Dolphin 3, Pile 2 (full system).

The CP systems for all four ICPW piles show a reduction in output current demand (Figure 27, Figure 29, Figure 31, and Figure 33) from the initial energizing level until February 2010, when fluctuations in the readings became erratic. The cause of fluctuation is unknown, and a longer period of monitoring results will need to be assessed to understand the behavior.

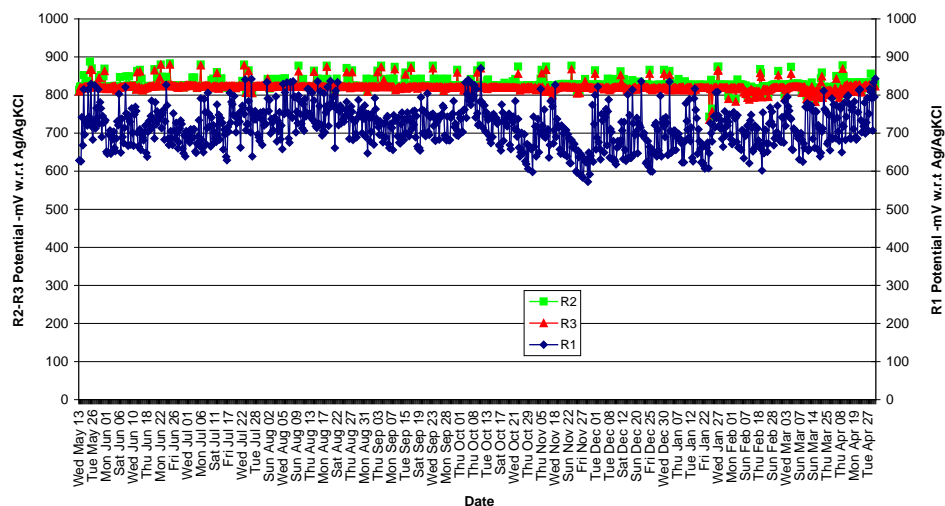
Figure 28. Instant-off potentials for first year, Dolphin 3, Pile 4 (full system).

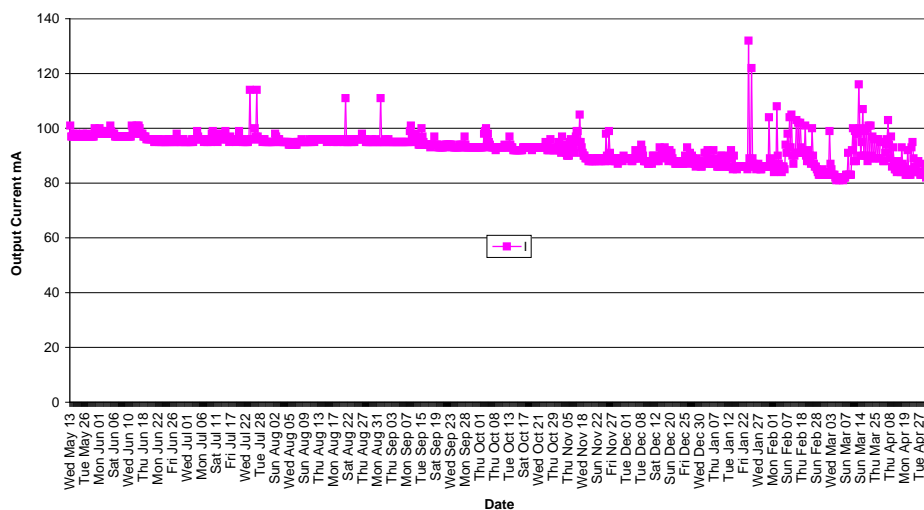
Figure 29. Output current for first year, Dolphin 3, Pile 4 (full system).

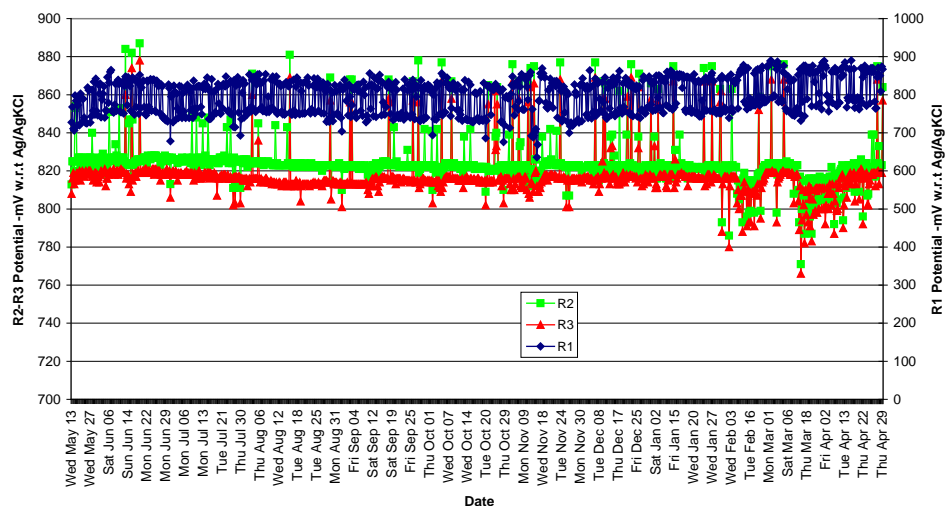
Figure 30. Instant-off potentials for first year, Dolphin 3, Pile 12 (full system).

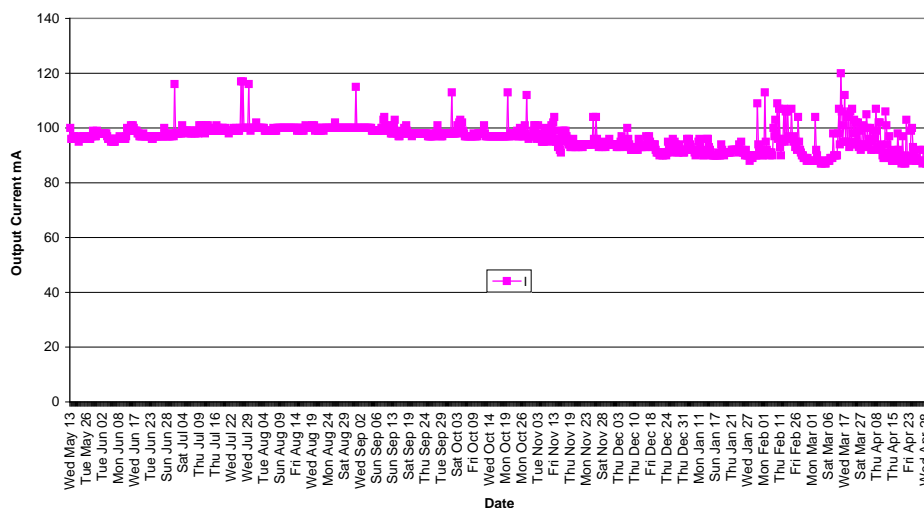
Figure 31. Output current for first year, Dolphin 3, Pile 12 (full system).

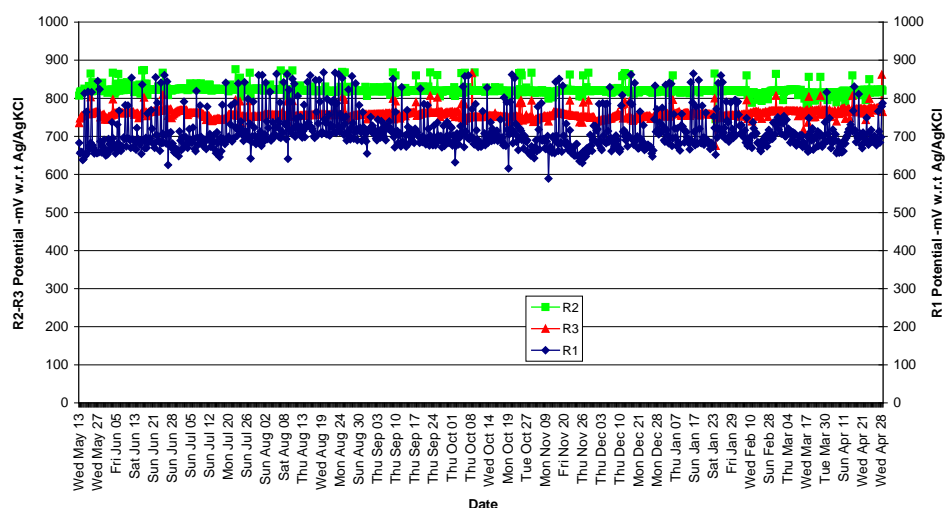
Figure 32. Instant-off potentials for first year, Dolphin 3, Pile 8 (full system).

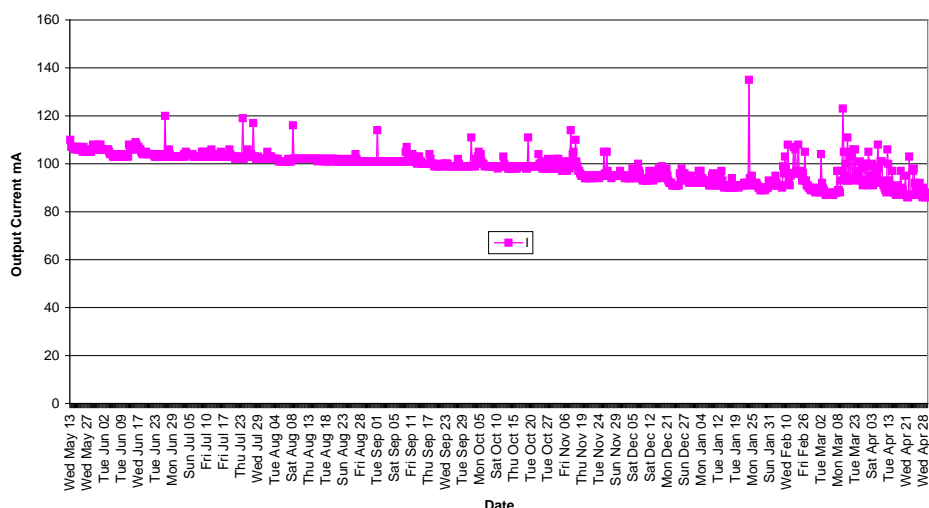
Figure 33. Output current for first year, Dolphin 3, Pile 8 (full system).

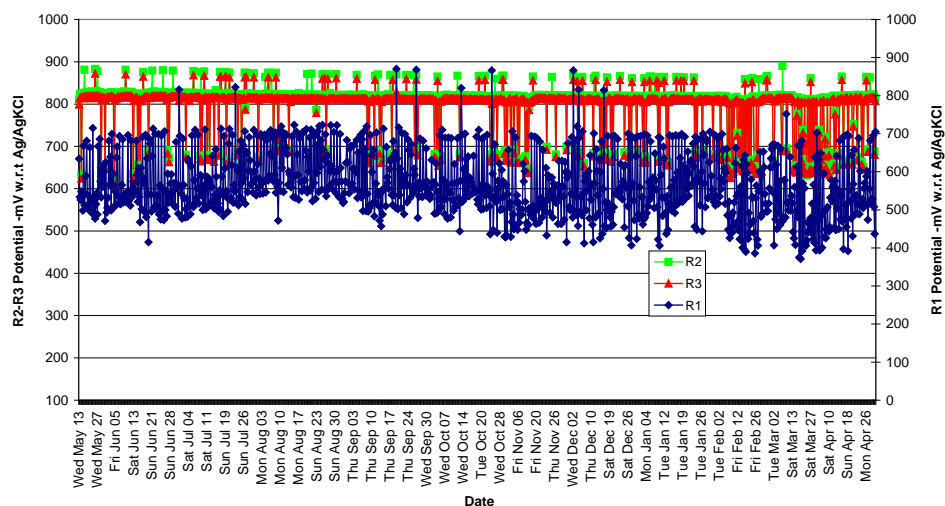
Figure 34 Instant-off potentials for first year, Dolphin 3, Pile 17 (wrap and bulk CP).

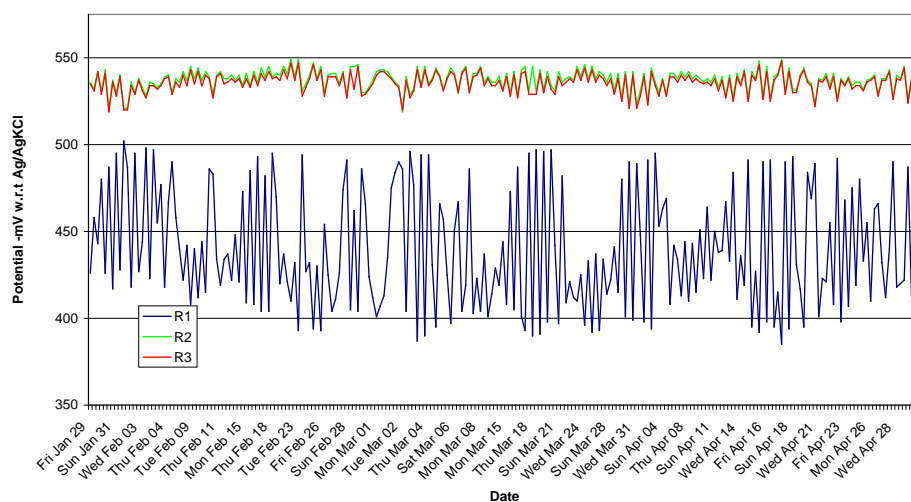
Figure 35. Instant-off potentials for first year, Dolphin 3, Pile 14 (wrap only).

Pile 14 had the composite wrap but no CP system, and Pile 16 had no wrap and no CP system. As was the case for Piles 13 and 15 of Dolphin 2, the in-

stant-off potentials for these two piles were only recorded after late January due to the same data-logging error. It can be seen in Figure 35 and Figure 36 that no CP is being provided to either pile at any of the three reference electrodes.

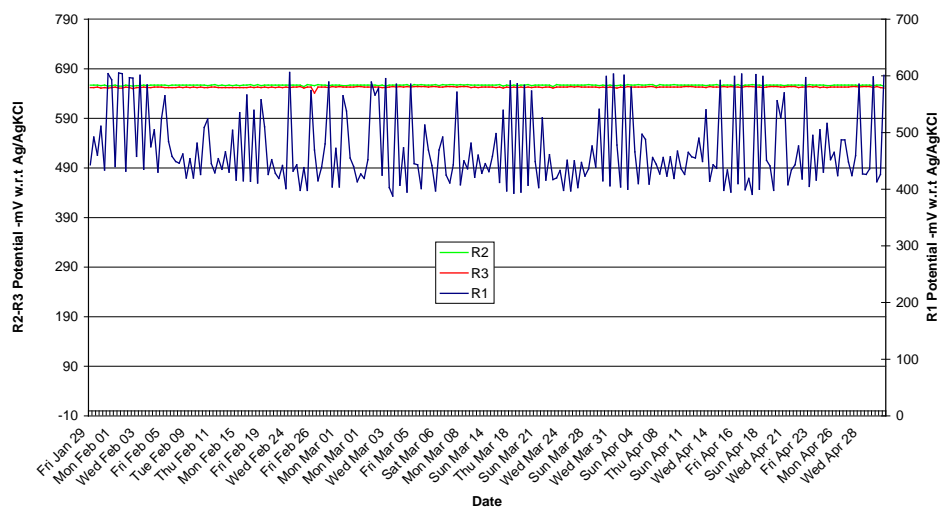
Figure 36. Instant-off potentials for first year, Dolphin 3, Pile 16 (no wrap or CP).
